Information regarding the partial collapse of the roof over the "turbine hall" of the Chernobyl reactors

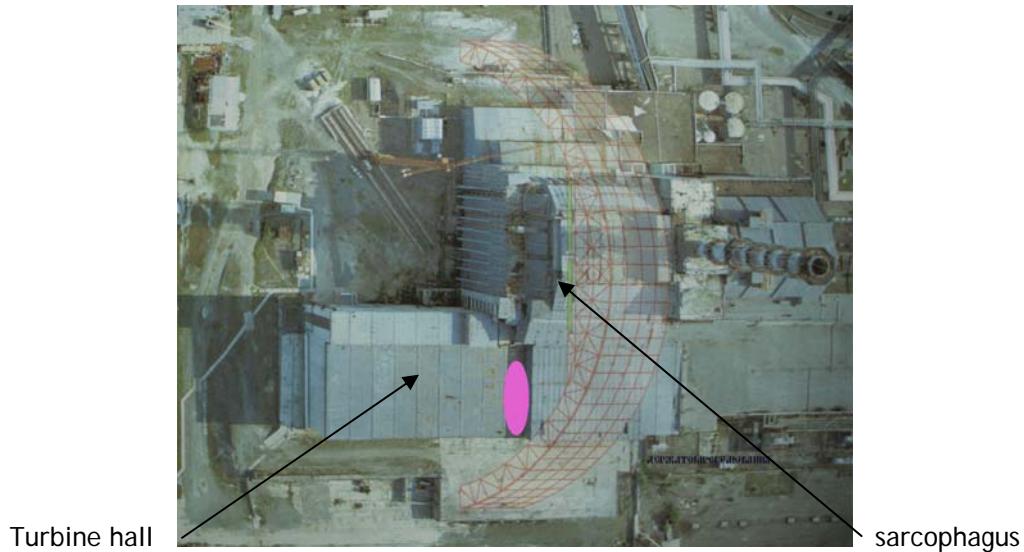
On 12 February 2013, a roof and a section of wall of the turbine hall of the Chernobyl reactors collapsed. The collapsed area is shown in the photograph below (pink area).

Note: In the picture above appears (red filigree) a representation of the future sarcophagus under construction on the site. Credits: Ukrainian Safety Authority.

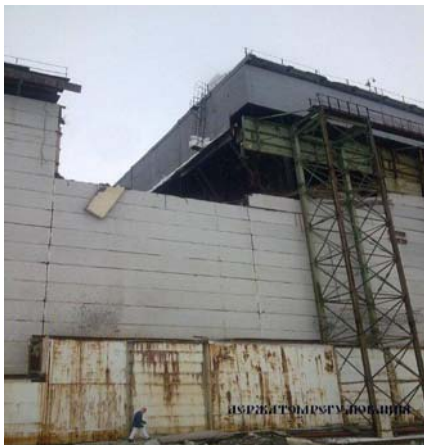
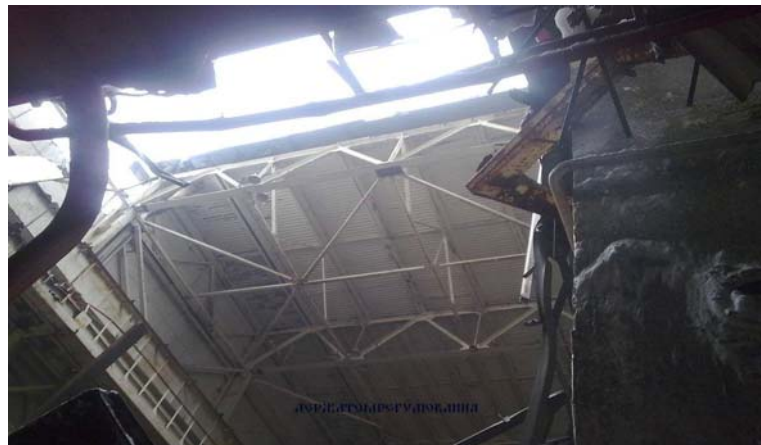
The collapse was caused by an accumulation of snow on the roof structural steelwork. The area is near the sarcophagus that was installed over the damaged reactor in 1986. The photos below show a view of the outer wall of the turbine hall, locally destroyed, and a view of the roof partially collapsed.

Credits: Ukrainian Safety Authority.

The Ukrainian Operator must now ensure the absence of effect on the overall behavior of the sarcophagus.

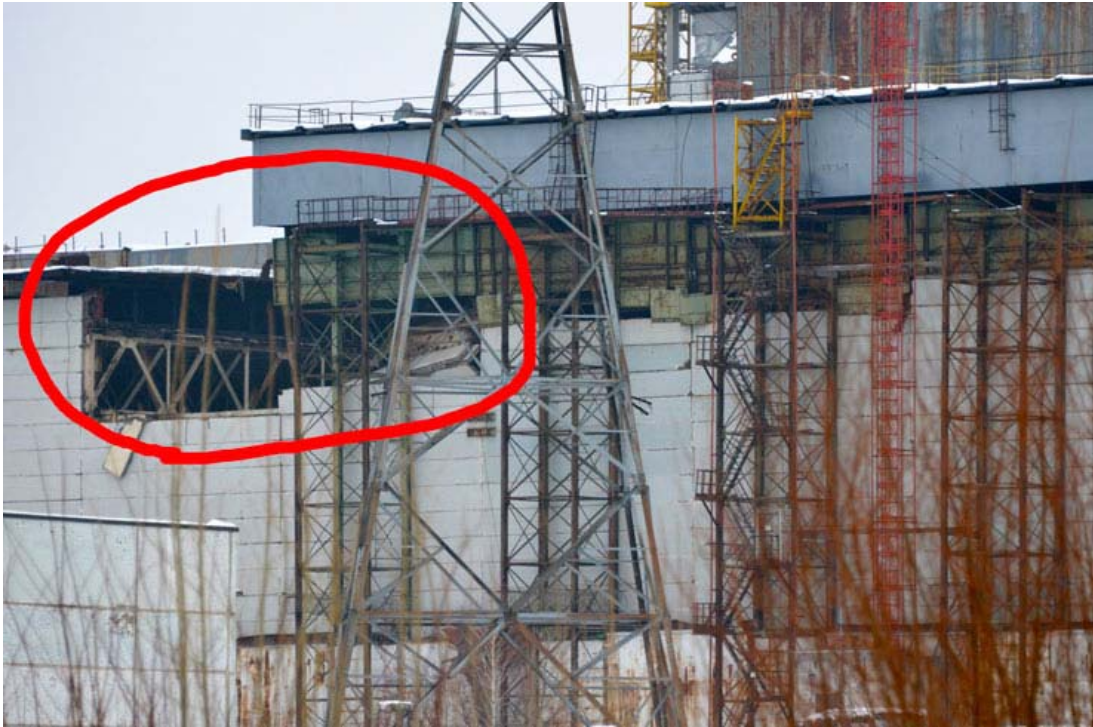
External view of the destroyed area of the turbine hall. Credits: Ukrainian Safety Authority.
